# Manhole Inspection Summary

Manhole # S21Y\_\_014MH

Insp Date: **11/25/08 9:15 AM**

**Location** Address: **2106 Maisel St.**

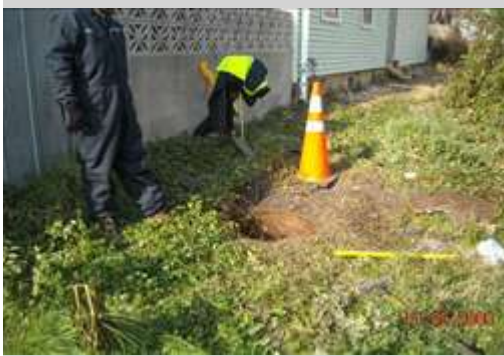
Location View

Comments **Located with the use of a metal detector. Manhole was located 4 inches underground, in which it had to be dug up. Also manhole is in an abandoned lot at address above. Manhole lid was an break and replaced with water tight lid. Manhole frame to be raised**
